**REVISED LIMITED STRUCTURAL EVALUATION OF
RAND ENGINEERING & ARCITECTURE DPC**

Re: 286 Rider Avenue
Limited Structural Evaluation (Rev. 1)

**286 RIDER AVENUE
PHOTOGRAPHIC SUPPLEMENT TO
RAND MARCH 29, 2022 LIMITED STRUCTURAL EVALUATION (REV.1)**

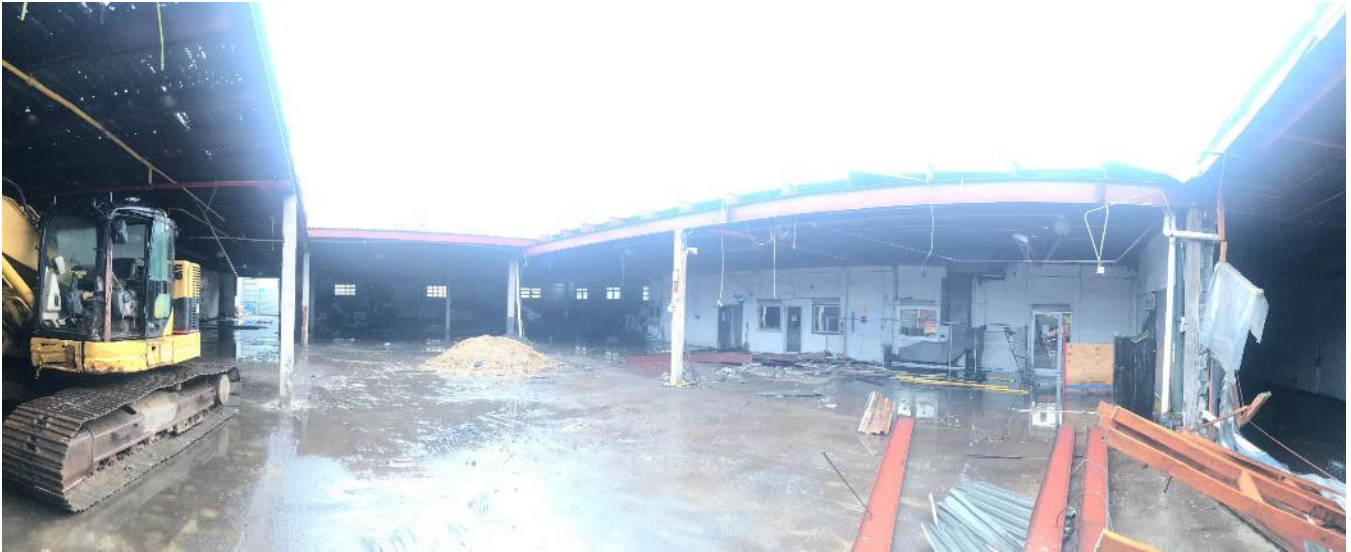
- The roofing system has been completely removed, exposing the interior spaces and structure to the elements. Standing water is present throughout. The finished office spaces in the northwest corner are completely waterlogged, with ceiling finishes and insulation falling to the floor (photos 1 through 4).

Photo 1. The warehouse interior is open and exposed to the elements.

- The entire structure is currently exposed to the elements due to the lack of roofing system and large and small openings through the metal deck. Temporary protection to divert rain water should be installed to protect the structure and foundations from ongoing deterioration and eventual destabilization. Roof protection should incorporate securing the remaining metal deck to avoid portions becoming dislodged.

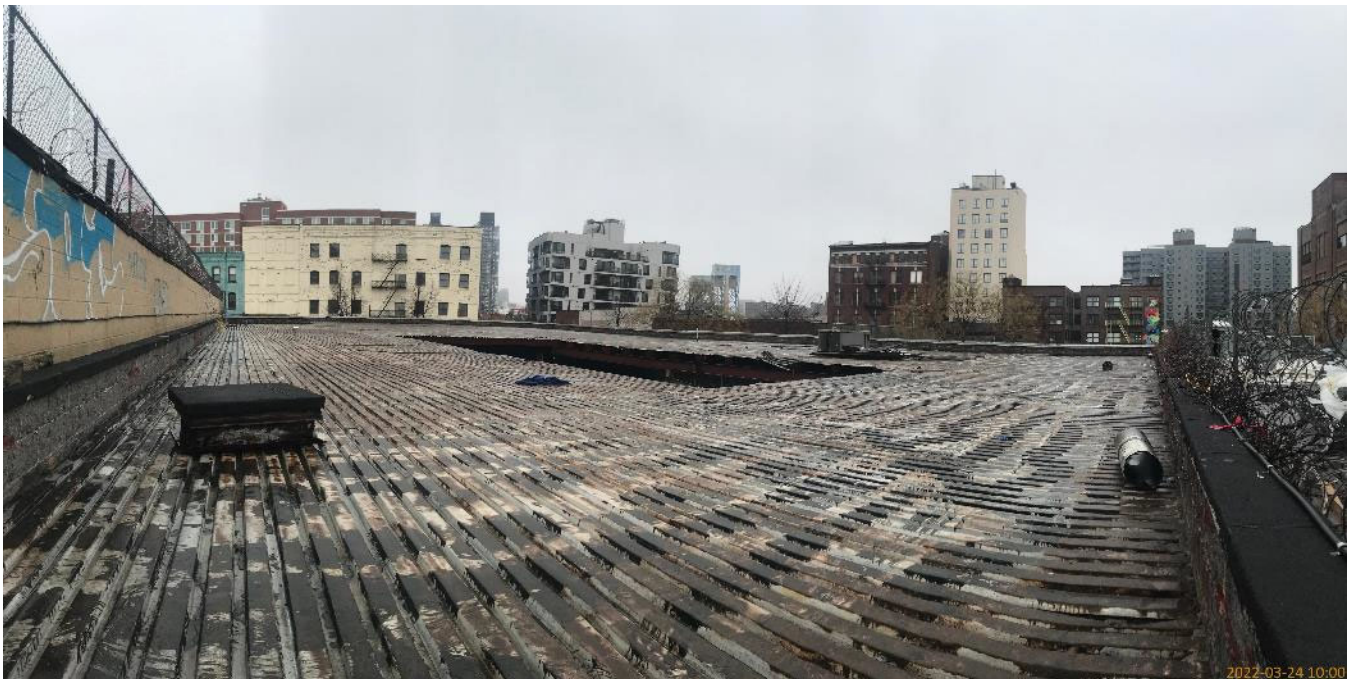
Photo 2. The roofing system has been completely removed down to deck.

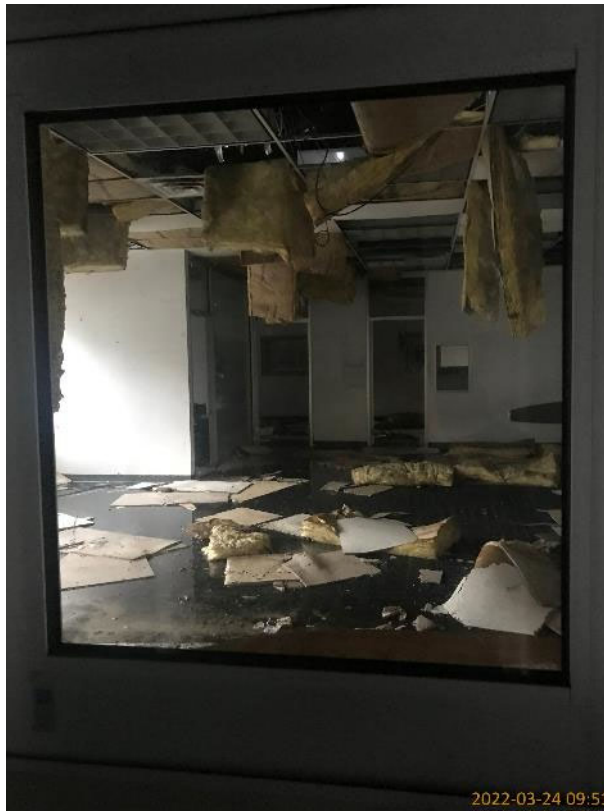
Photo 3. Finished office spaces are waterlogged with finishes and insulation falling to the floor.

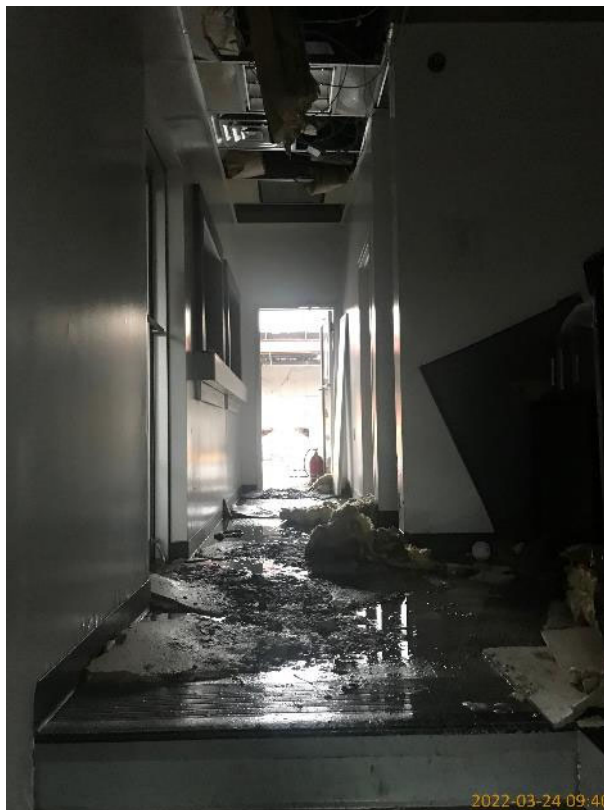
Photo 4. Finished office spaces are waterlogged with finishes and insulation falling to the floor.

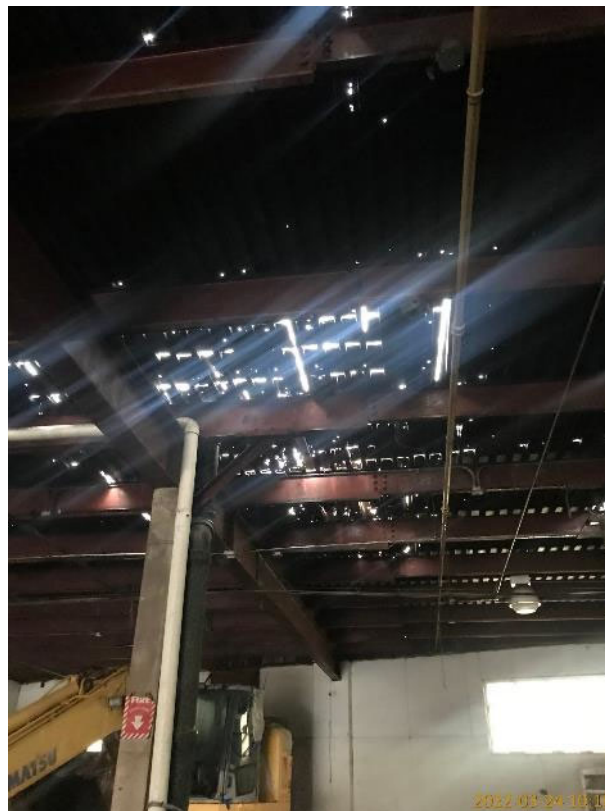
- The roof metal deck is significantly deteriorated, with holes and daylight visible throughout (photo 6). A walkthrough of the deck (including observation of attachment) from the rooftop was not performed due to safety concerns.

Photo 6. The roof metal deck is significantly deteriorated.

- The roof hatch at warehouse northeast corner should be closed off to prevent access to the roof which does not appear safe to walk on. It is possible that sections of the deck between framing are too weak to support snow loads and may fail in the future. Since the building will eventually be demolished, replacement or reinforcement is impractical. The roof should be re-evaluated by a structural engineer ahead of next winter for further recommendations. In general, the building should be secured and access restricted to only authorized personnel.

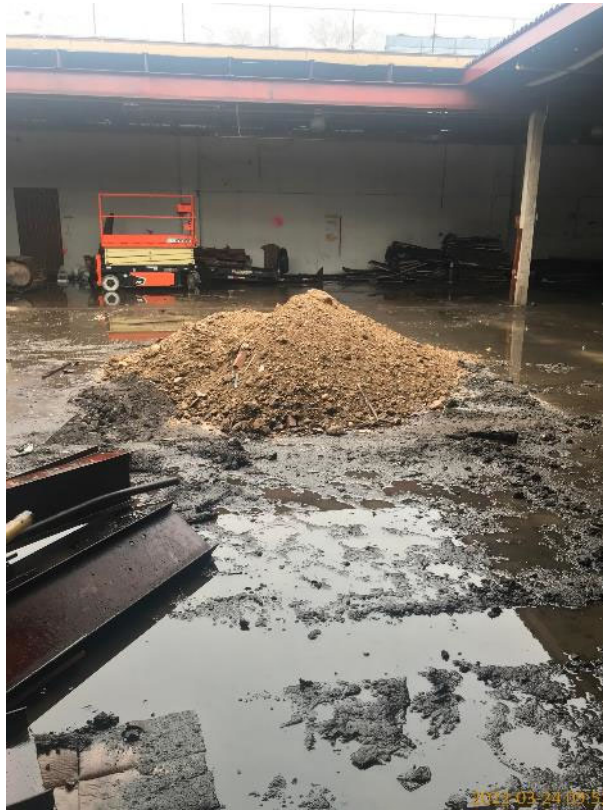
- A large opening has been cut into the concrete floor beneath the opening in the roof. It appears that underlying grade has been partially excavated and subsequently filled with an uncompacted pile of earth (photo 9).

Photo 9. A section of the warehouse floor slab-on-grade has been cut away, partially excavated, and filled with uncompact earth.

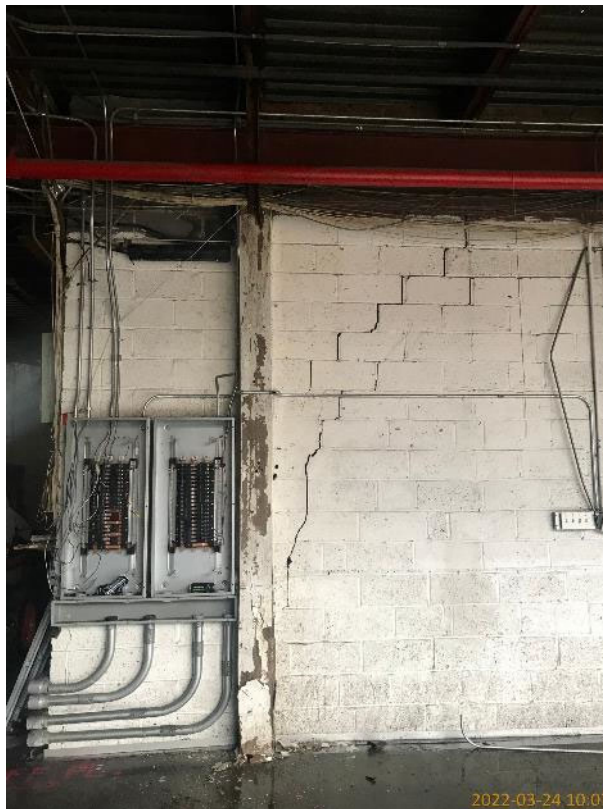
- A large crack was observed in the interior CMU partition. This condition is indicative of prior movement but does not appear to be a safety hazard at this time (photo 10).

Photo 10. Crack in CMU wall at southeast corner of the office enclosure.

- As a precaution, the large partition crack at the southeast corner of the office enclosure should be monitored for movement. It is recommended that a crack monitor be installed so that any widening or shifting can be easily observable.

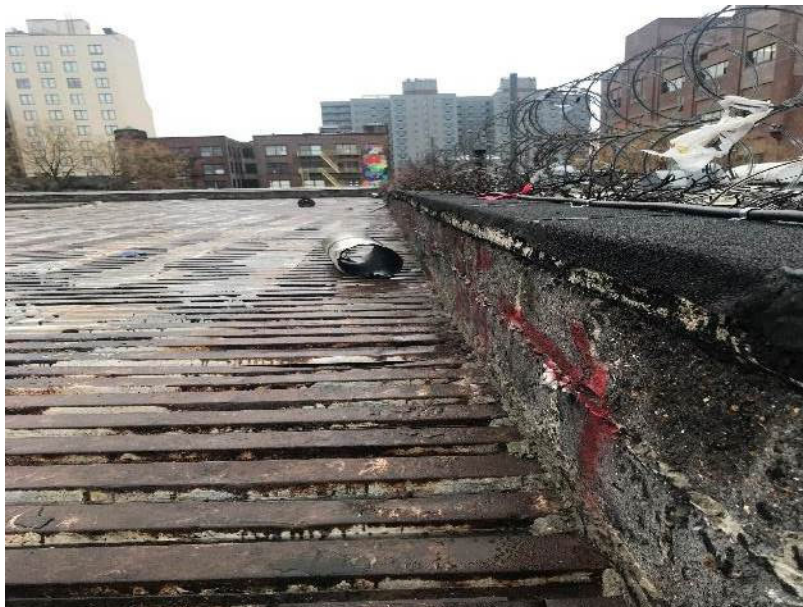
- The adjoining buildings to the north (supermarket) and east (laundromat) appear to be separated structurally at the property line. Barbed wire fences are situated at the roof perimeter preventing access to the site from the adjoining rooftops (photos 13 and 14).

Photo 14. Barbed wire fencing at roof level prevents access from adjoining rooftops.
